# COMPREHENSIVE ASBESTOS SURVEY

COMMERCIAL BUILDING  
311 EAST MAIN STREET  
MONCK'S CORNER, SOUTH CAROLINA 29461

Commercial Building  
311 East Main Street  
Moncks Corner, South Carolina 29461

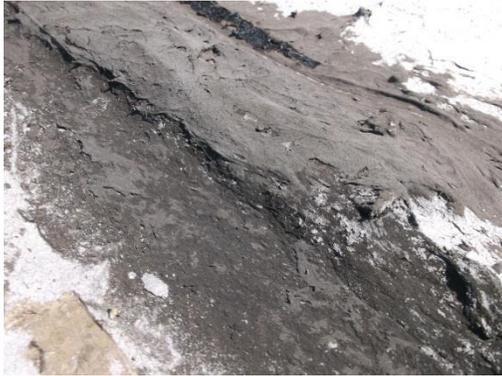
Asbestos fibers were identified in the Roof Cement (black). Approximately 500 square feet is present and in good condition. This material is considered Category I – Non Friable Asbestos and is located on the Exterior Roof.

HOMOGENEOUS AREA 01  
ROOF CEMENT (BLACK)

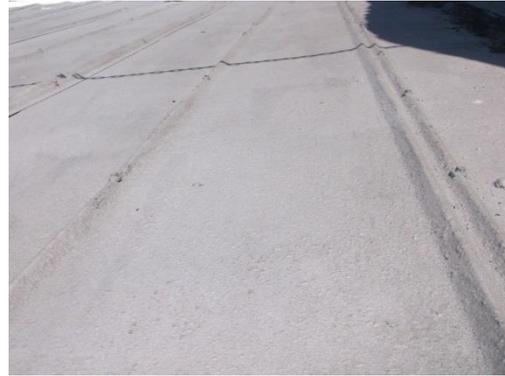
HOMOGENEOUS AREA 02  
ALUMINIZED COATING

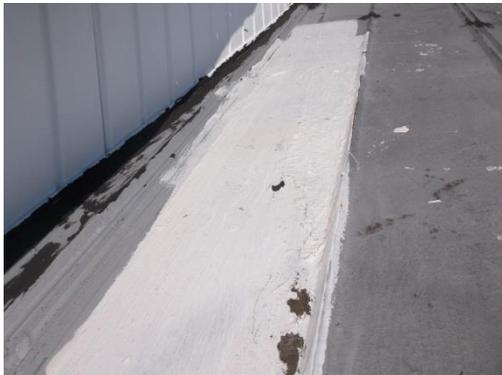
Asbestos fibers were identified in the Roof Caulk (white). Approximately 550 square feet is present and in good condition. This material is considered Category I – Non Friable Asbestos and is located on the Exterior Roof (see diagram).

HOMOGENEOUS AREA 03  
ROOF CAULK (WHITE)

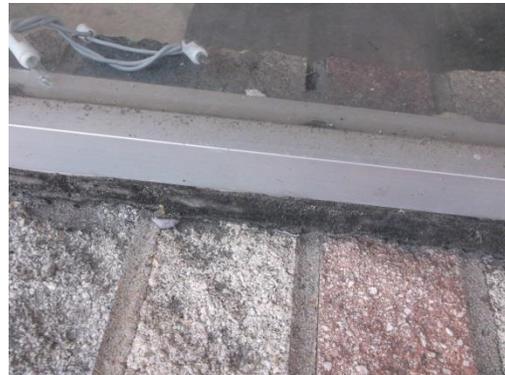
HOMOGENEOUS AREA 04  
EXTERIOR CAULK

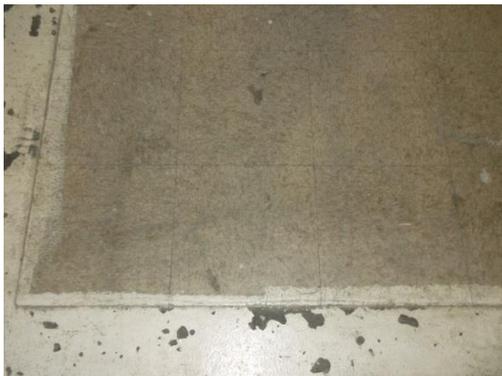
Asbestos fibers were identified in the 9” Floor Tile (beige). Approximately 110 square feet is present and in good condition. This material is considered Category I – Non Friable Asbestos and is located in the sales area (see diagram).

Asbestos fibers were identified in the Floor Tile Mastic (black). Approximately 110 square feet is present and in good condition. This material is considered Category I – Non Friable Asbestos and is located in the sales area (see diagram).

HOMOGENEOUS AREAS 05, 06  
9" FLOOR TILE (BEIGE)  
MASTIC (BLACK)

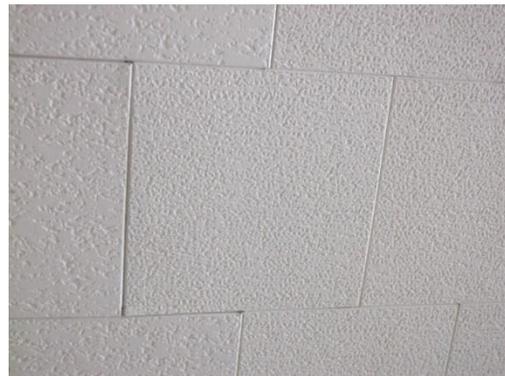
HOMOGENEOUS AREA 07  
1' x 1' CEILING TILES (TEXTURE)

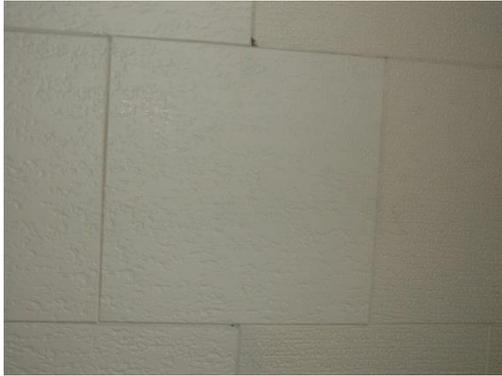
HOMOGENEOUS AREA 108  
1' x 1' CEILING TILES (DOTS)

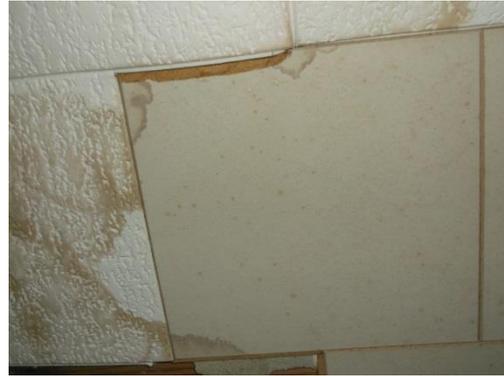
HOMOGENEOUS AREA 09  
1' x 1' CEILING TILES (SMOOTH)

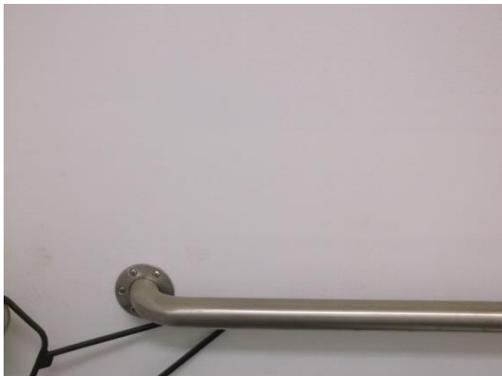
Asbestos fibers were identified in the Drywall/Joint Compound. Approximately 2,000 square feet is present and in good condition. This material is considered RACM – Friable Asbestos and is located in the sales area and restroom (see diagram).

HOMOGENEOUS AREA 10  
DRYWALL

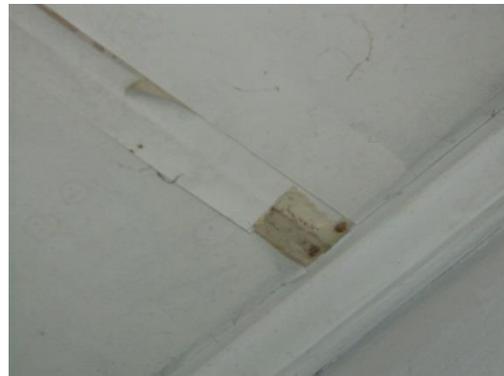
HOMOGENEOUS AREA 11  
JOINT COMPOUND
