# COMPREHENSIVE ASBESTOS SURVEY

COMMERCIAL BUILDING  
311 EAST MAIN STREET  
MONCK'S CORNER, SOUTH CAROLINA 29461

Commercial Building  
311 East Main Street  
Moncks Corner, South Carolina 29461

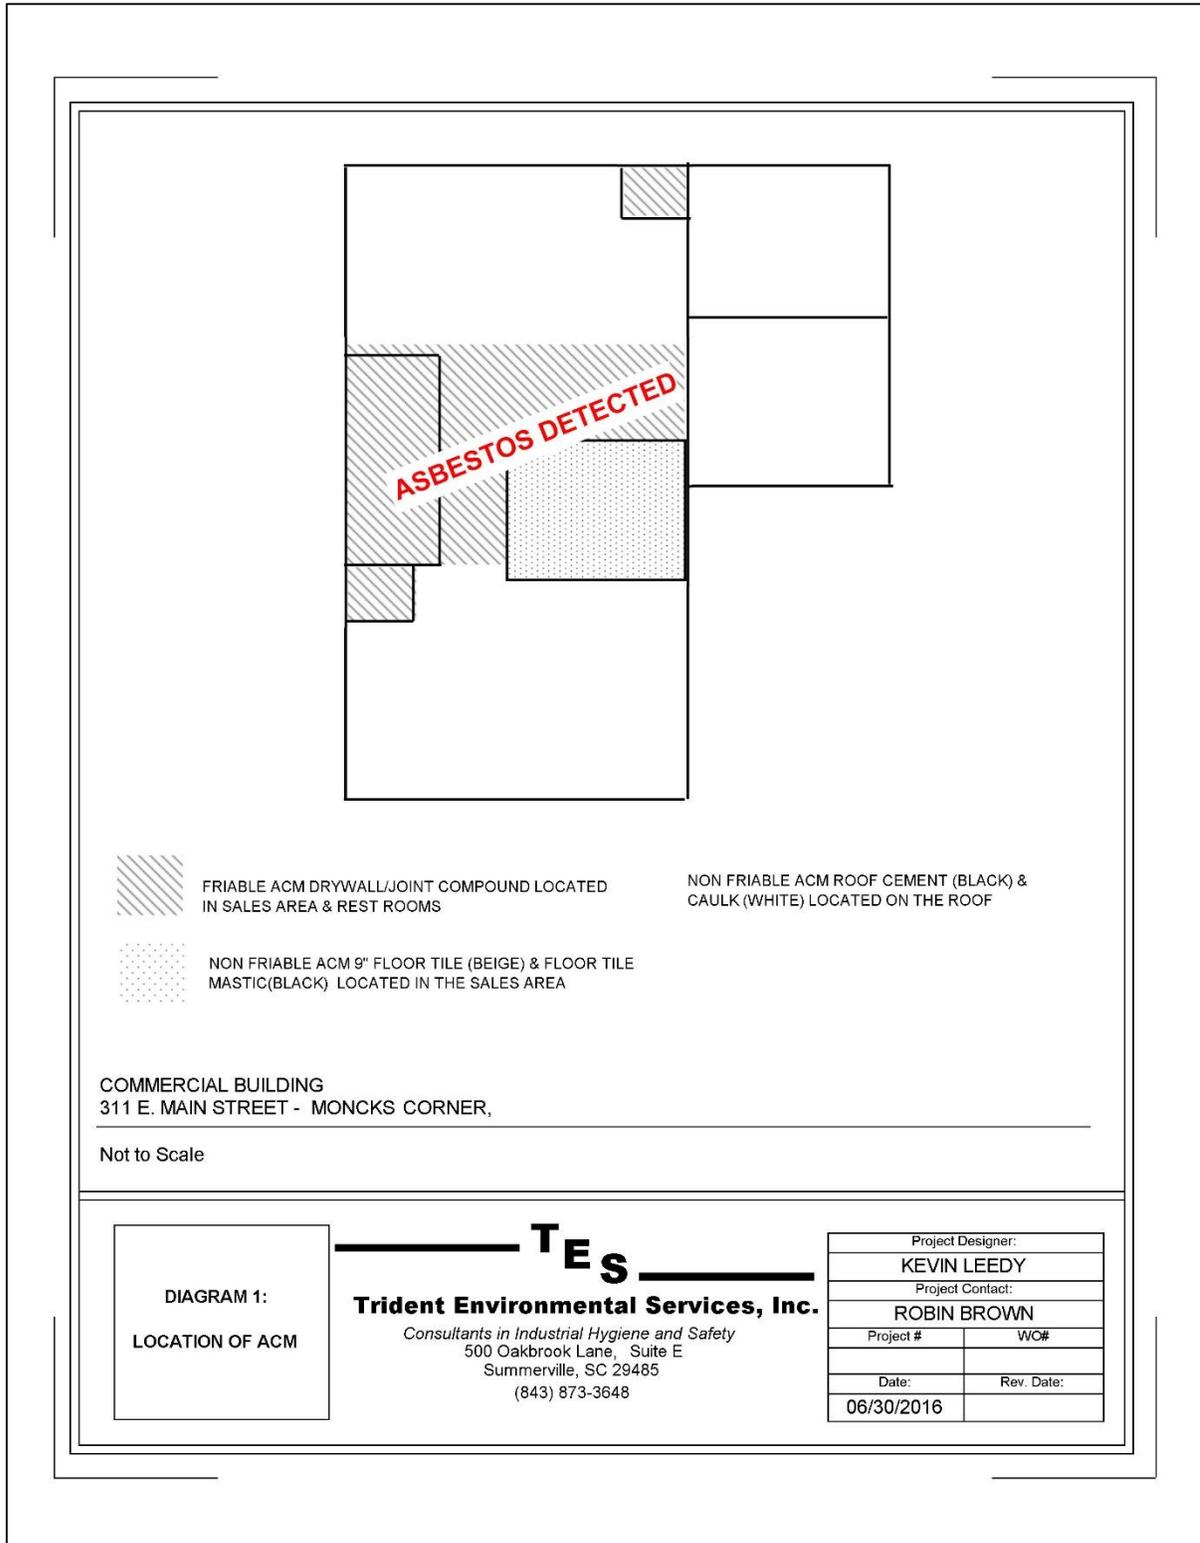
HOMOGENEOUS AREA 11  
JOINT COMPOUND

Asbestos fibers were identified in the Drywall/Joint Compound. Approximately 2,000 square feet is present and in good condition. This material is considered RACM – Friable Asbestos and is located in the sales area and restroom (see diagram).
